Drying Log Report

Claim Information

Project Information for Water Damage Area

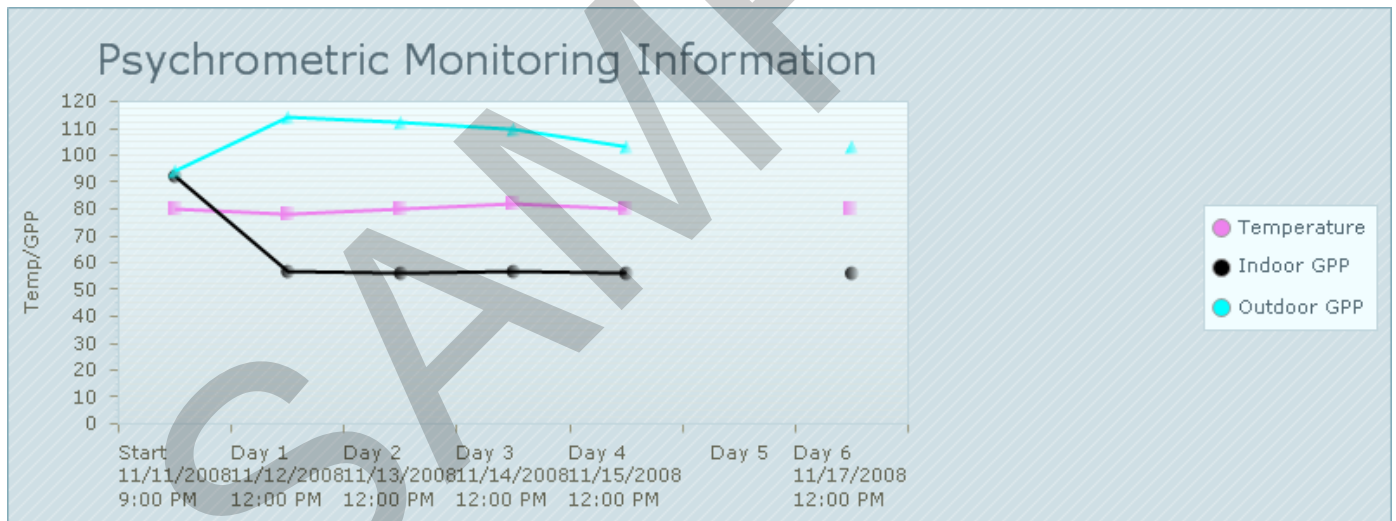
Psychrometric Monitoring Information

- 1 Contractor missed 1 daily monitoring visit(s) to reposition equipment. This lack of daily air mover repositioning may have lengthened the project duration.
- 2 Indoor air temperature was ideal to promote substrate drying with a range of 78 to 82.
- 3 Based on specific humidity (GPP) information, ambient air conditions were ideal to promote substrate drying. Excluding the first visit, GPP ranged from 56 to 57 during the project.

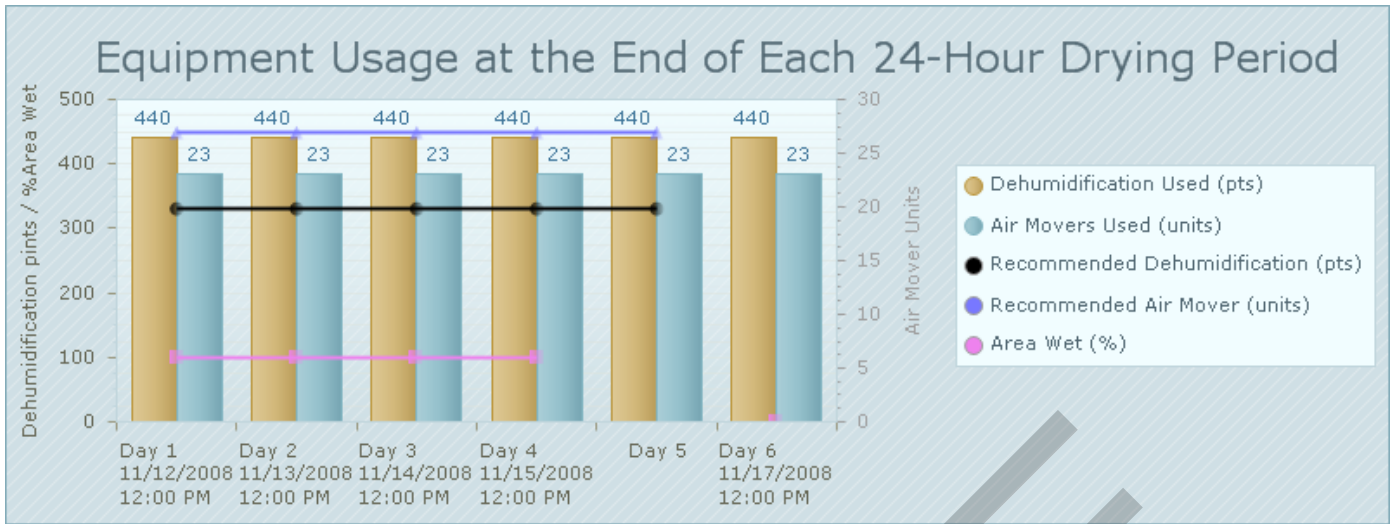
Dehumidifier and Air Mover Information

- 4 Based on linear feet of wall in the water damaged area, the recommended air mover usage was 27 units.
- 5 Initial daily air mover usage was 23 units and daily usage remained constant during the project.
- 6 Based on available equipment, the recommended initial daily dehumidification capacity was 330 pints using a 3 DrizAir 2000 unit(s).
- 7 Initial daily dehumidification capacity was 440 units and ranged from 440 to 440 pints. Dehumidification capacity exceeded recommended capacity by greater than 10% on 5 visit(s) of the 6 day project.

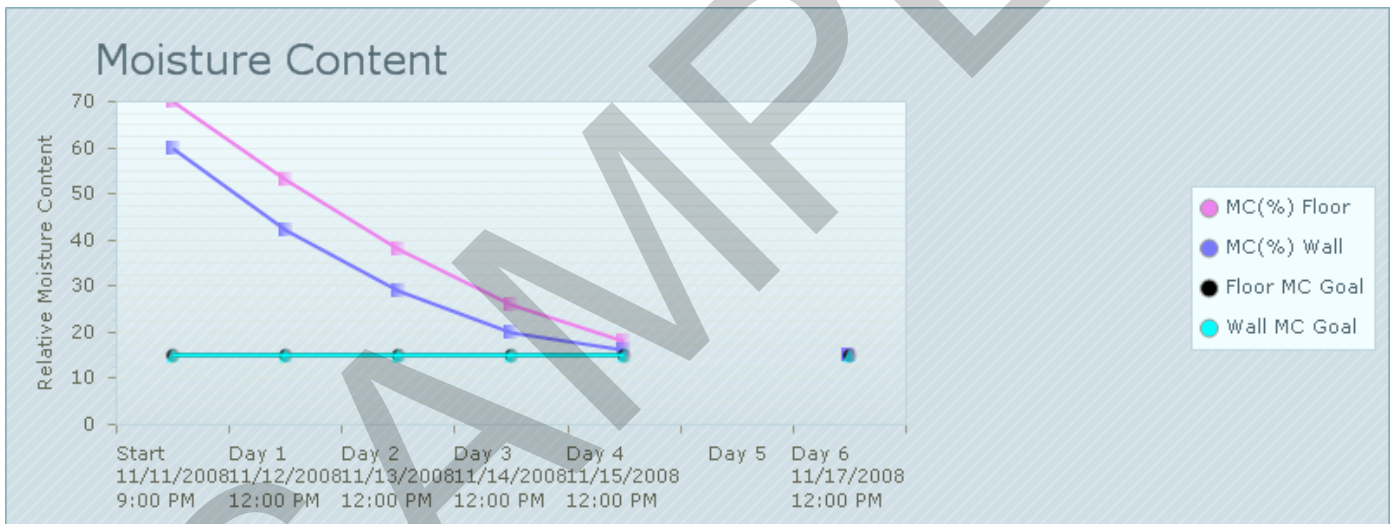
Substrate Moisture Content Information

- 8 The drying project was satisfactorily completed on Visit 6 but there was 1 missed monitoring visit(s) for equipment repositioning during the 6 day project. Therefore, the equipment rental period should not exceed 5 days.
